Red Line/Blue Line Connector Project

Massachusetts Department of Transportation
Boston, Massachusetts

March 2010

Hazardous Materials Inspection

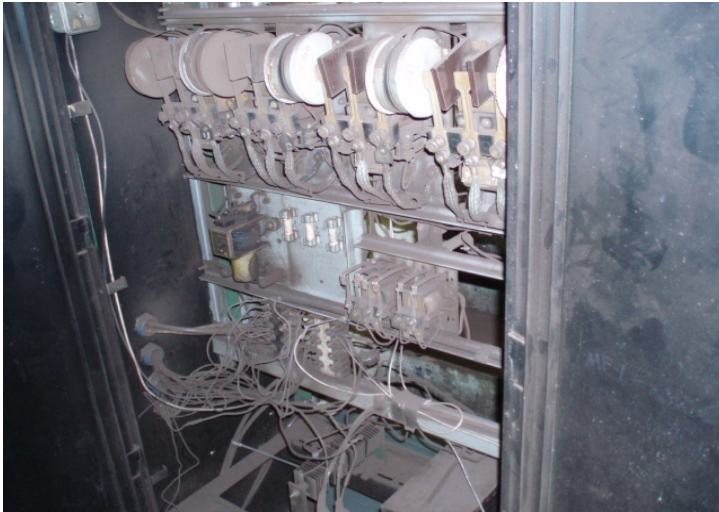
1. View of suspect asbestos-containing transite discs located in an electrical room within Bowdoin Street Station.

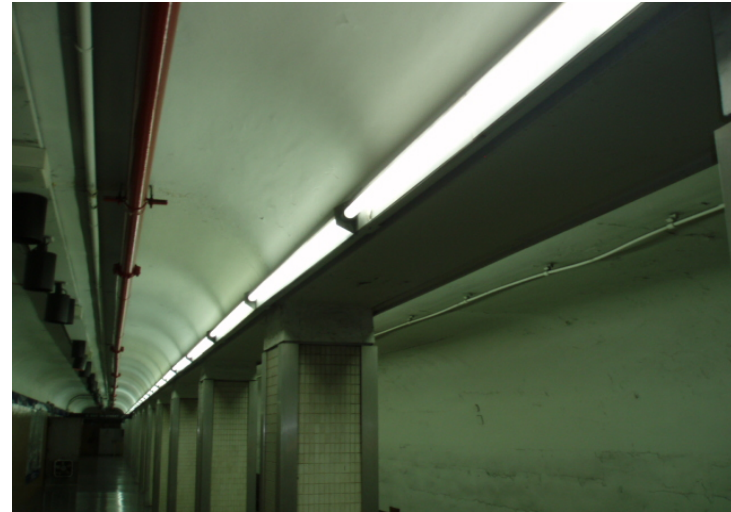
TRC observed numerous suspect mercury-containing lamps in fluorescent light fixtures throughout various areas of the Project Corridor (Photograph No. 2). The lamps were noted to be in good condition.

As discussed in Section 1.3.2, fluorescent light fixtures were observed throughout the Project Corridor. TRC believes that the fluorescent light fixtures predate 1978 and, therefore, the light ballasts could contain PCBs within asphalt-like mixture within the ballasts. Observed fluorescent light fixtures and ballasts appeared in good condition and did not exhibit signs of leakage.

2. View of fluorescent light fixtures observed in various lighted areas throughout the Project Corridor. The fixtures contain suspect PCB-containing ballasts.

As required by hazardous waste regulations, used fluorescent lamps must be managed in accordance with the State-adopted *Universal Waste Rule* (310 CMR 30.1000). Lamps or tubes removed from the light fixture must be stored properly, labeled, and disposed of within 1 year.

1. Manage fluorescent light ballasts in accordance with the Massachusetts hazardous waste management regulations (310 CMR 30.000), based on the PCB concentration.. Prior to disposal, ballasts should be checked for PCB concentration. For all non-PCB ballasts (i.e. less than 50 ppm PCBs), the waste ballasts should be managed as oily wastes (MA01 wastes), and ballasts containing greater than 50 ppm PCBs, must be managed as PCB-contaminated or PCB-containing hazardous wastes (MA02 wastes). Special handling requirements are needed for leaking, PCB-contaminated and PCB-containing ballasts.
2. Manage other suspect PCB-containing materials (busing insulation within high voltage conduit, doorway and stairwell caulking, and mastics) in accordance with Massachusetts hazardous waste management regulations.

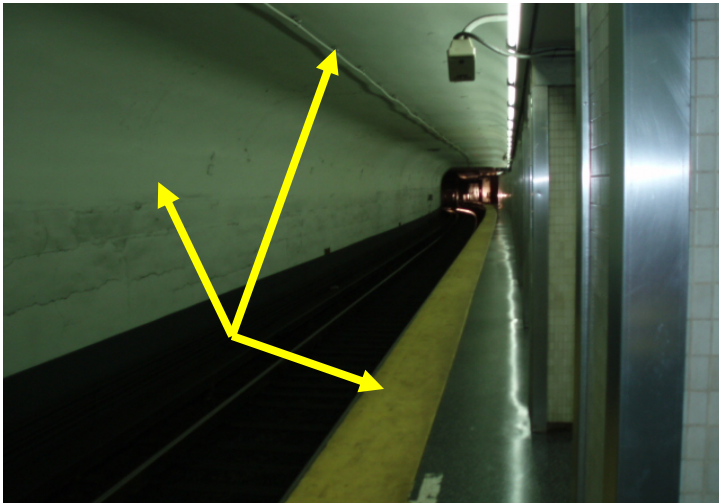
TRC identified various surfaces suspected to be coated in LBP due to the age of the structures. These surfaces generally include plaster-coated walls and ceilings (Photograph Nos. 3 and 4), metal doors and frames, (Photograph No. 7), ceramic tiles (Photograph No. 5), support columns (Photograph No. 11), and metal stairwells and railings (Photograph No. 6). In addition, TRC suspects that the yellow-painted caution strips at each train platform may contain LBP (Photograph No. 3). The conditions of observed surfaces ranged from poor (i.e. flaking) to good condition. Dust was observed throughout the Project Corridor. It is possible that a portion of the dust is from the disintegration of the above mentioned painted surfaces. TRC also observed white, tan, and blue glazed ceramic tiles and wall blocks throughout the Project Corridor. Glazes used on these materials are suspected to contain lead. The glazed ceramic tiles were generally in good condition.

3. View of painted wall, ceiling, and yellow caution strip suspected to contain lead-based paint.

1. Suspect LBP within the Project Corridor which may be disturbed should be tested by EPA-licensed Lead Inspectors using X-Ray Fluorescence (XRF) Analyzers, or sampled for laboratory analysis. The Inspectors should also conduct random dust wipe tests to confirm or deny the presence of lead in dust within the Project Corridor.

2. Contractors performing work that will disturb LBP or lead in dust at the Site should comply with the requirements of OSHA standard 29 CFR 1926.62, *Lead in Construction Standard*, as well as applicable federal, state, and local requirements pertaining to the disturbance of LBP.

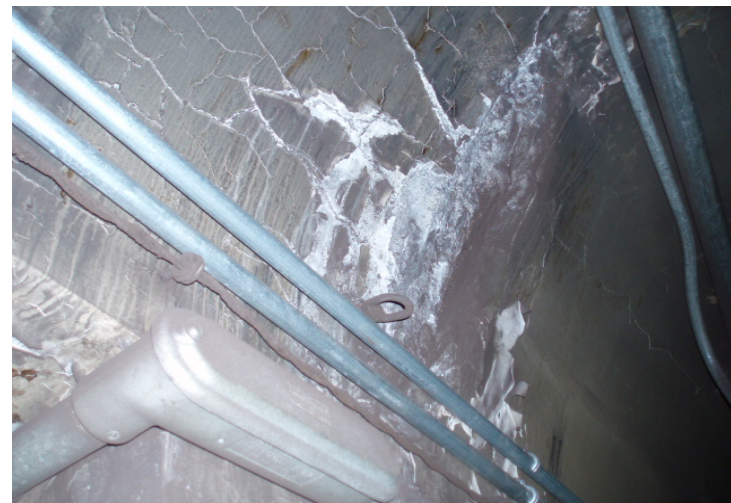
4. View of damaged suspect asbestos-containing plaster skim coat. The painted surface of the skim coat is suspected to contain lead-based paint.

1. Identified suspect ACM should be quantified and sampled by Massachusetts-licensed Asbestos Inspectors for asbestos content in accordance with Environmental Protection Agency (EPA) NESHAPS and OSHA requirements;
2. ACM positively identified through laboratory analysis, in materials that will be demolished during construction, should be removed prior to or during the construction activity, by a Massachusetts-licensed asbestos abatement contractor in accordance with applicable federal, state, and local regulations; and
3. Prior to the start of renovation/demolition activities that may disturb identified ACM, TRC recommends that a Massachusetts-licensed Asbestos Designer prepare a project specification that would reference applicable regulations and work practices that the asbestos abatement contractor must follow.

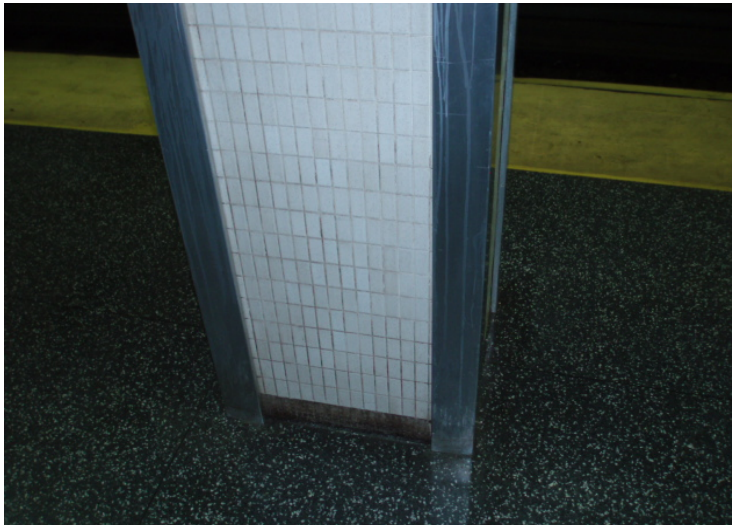
5. View of white ceramic tiles suspected to contain lead. The tiles were observed on support columns and walls in various areas throughout the Project Corridor.

3. Glazed ceramic tiles suspected to be lead-containing and which may be disturbed should be sampled by EPA-licensed Lead Inspectors and analyzed via *Toxicity Characteristic Leaching Procedure (TCLP) Methods SW846-1311/7420* in accordance with federal waste management regulations prior to demolition waste disposal. A green alternative to disposal would be reusing the decorative tiles; thereby avoiding the disposal and sampling requirements.

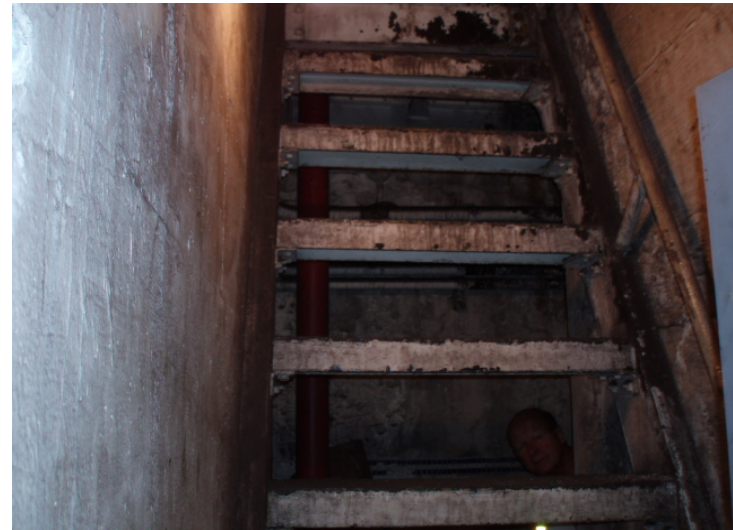
6. View of a steel stairwell and railing located at an emergency exit within Bowdoin Street Station. The stairwell is coated in paint suspected to be lead-based.

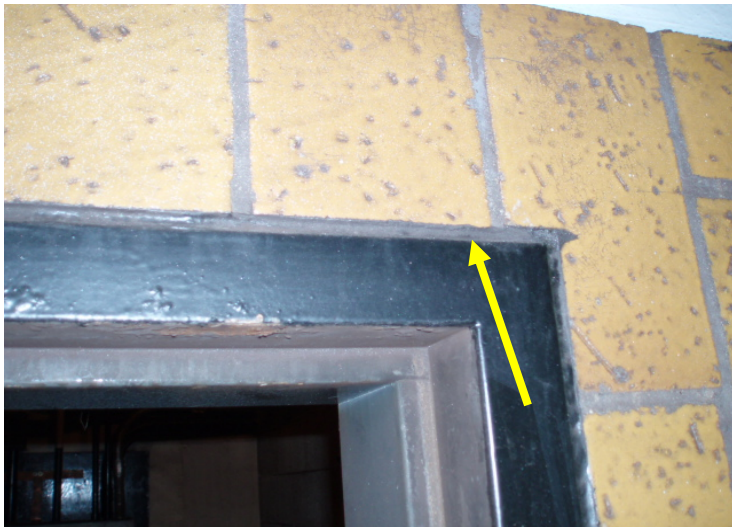
TRC also observed several other suspect PCB-containing materials within the Project Corridor including busing insulation within high voltage conduit (Photograph No. 10), doorway and stairwell caulking (Photograph Nos. 7 and 8), and mastics.

7. View of suspect PCB/asbestos-containing caulking typically found around door frames within the Project Corridor.

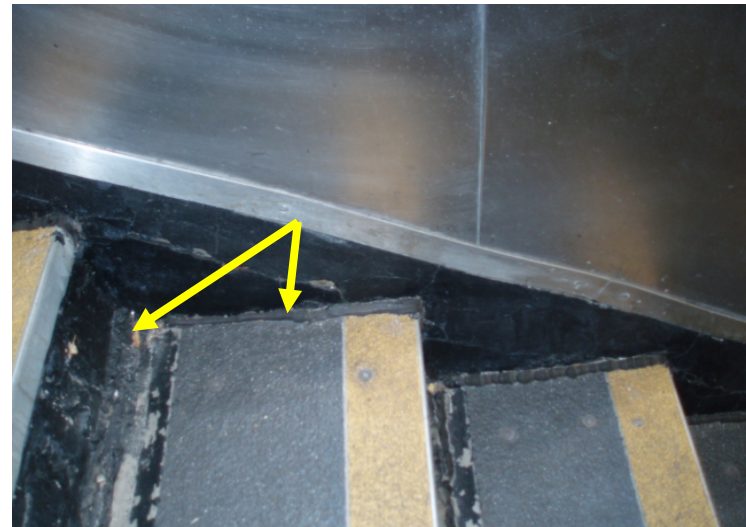
8. View of suspect PCB/asbestos-containing caulking identified on stairwells within the Project Corridor.

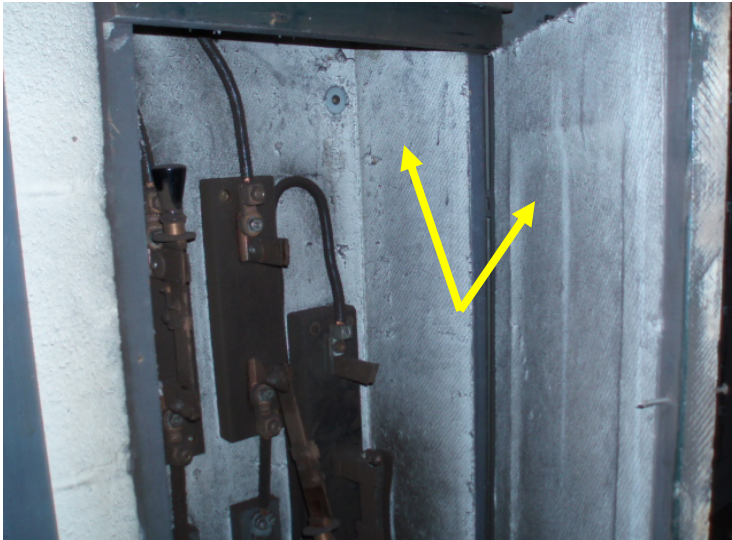
9. View of suspect fiber board located within wood panel electric boxes and other areas within the Project Corridor.

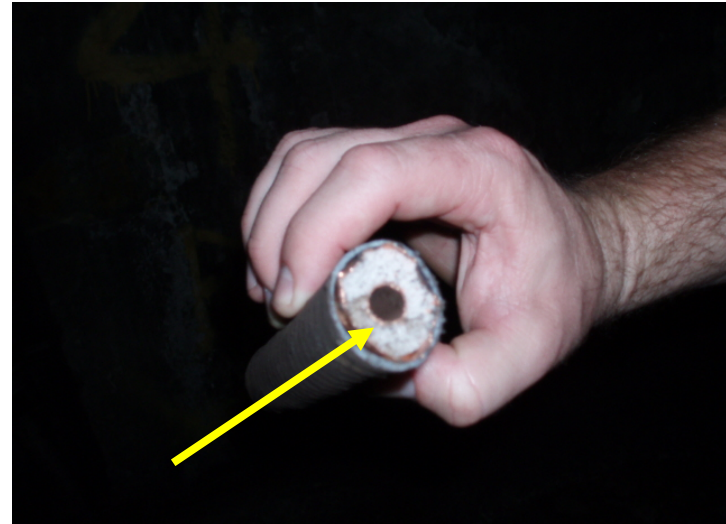
PCBs may also be present in busing insulation within high voltage conduit, doorway and stairwell caulking, and mastics. PCB labels were not observed on any of the ballasts or busing insulation.

10. View of busing insulation which may contain suspect asbestos wrap and/or PCBs. The material is typically found in high-voltage conduits within the Project Corridor.

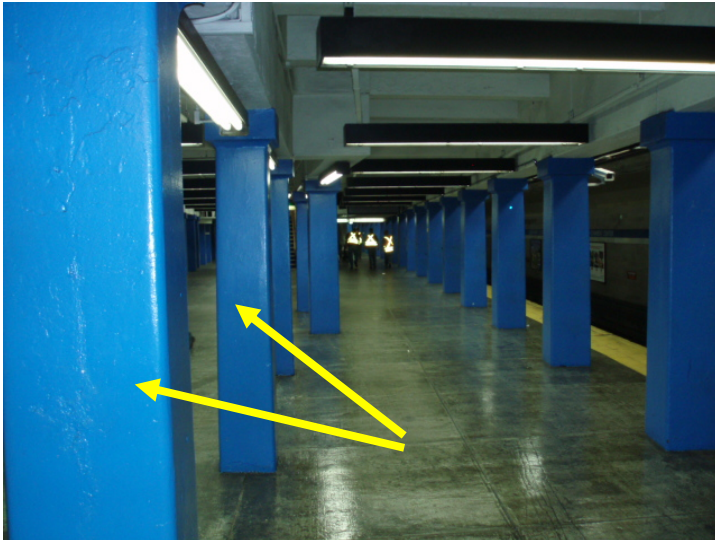
11. View of painted support columns suspected to contain lead-based paint.

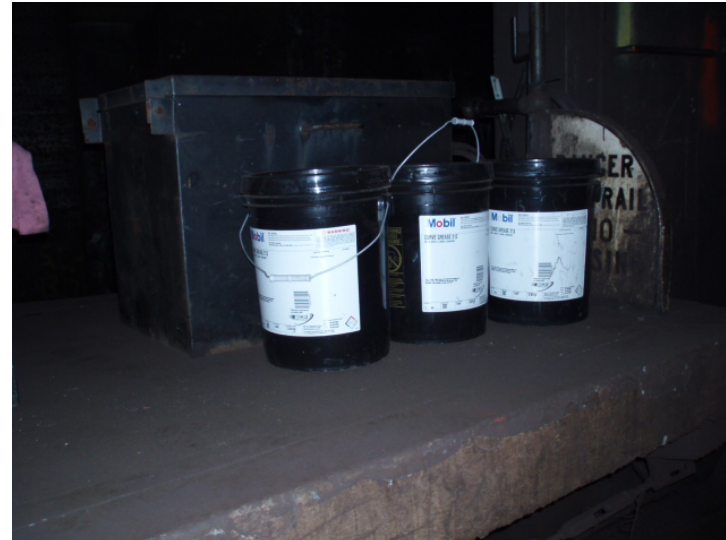
TRC observed several 5-gallon closed containers of curve grease (also known as "rail grease") located on a concrete pad within the Project Corridor (Photograph No. 12). The containers were in good condition with no evidence of leaks. According to MBTA personnel, grease is used on both trains and tracks during typical railway maintenance operations. TRC observed grease on the tracks and on underlying stone and ties throughout the Project Corridor (Photograph No. 13); the majority of which was observed within the Bowdoin Yard Tunnel.

TRC observed a minor quantity of 5-gallon closed containers of curve grease located on a concrete pad within the Project Corridor. The containers were in good condition with no evidence of leaks.

12. View of 5-gallon containers of curve grease used for typical railway maintenance operations

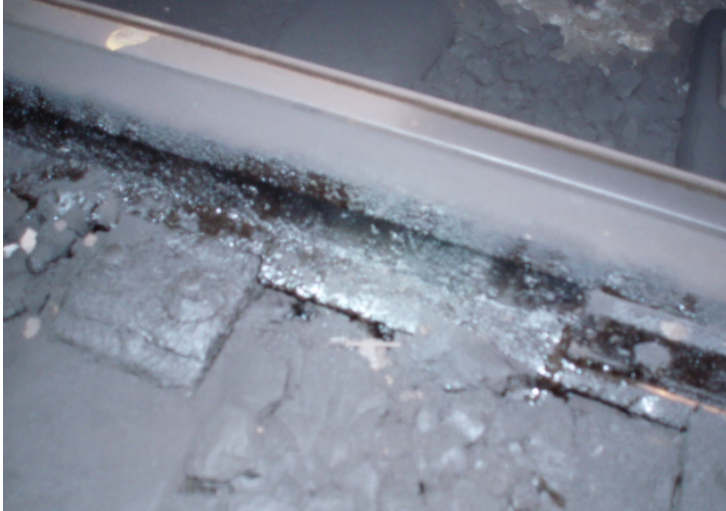
TRC observed some areas of grease on the tracks and on underlying stone and ties throughout the Project Corridor; the majority of which was observed within the Bowdoin Yard Tunnel. However, there were no large areas of grease beneath the tracks that would indicate a reportable release under the MCP.

13. View of curve grease on train railway.

1. Manage petroleum impacted materials (track, stone, and ties) in accordance with the Massachusetts hazardous waste management regulations if disturbed during modification or demolition construction activities. If during constructing activity petroleum impacted soil is identified beneath the track a reportable condition may exist and will need to be managed in accordance with the MCP.

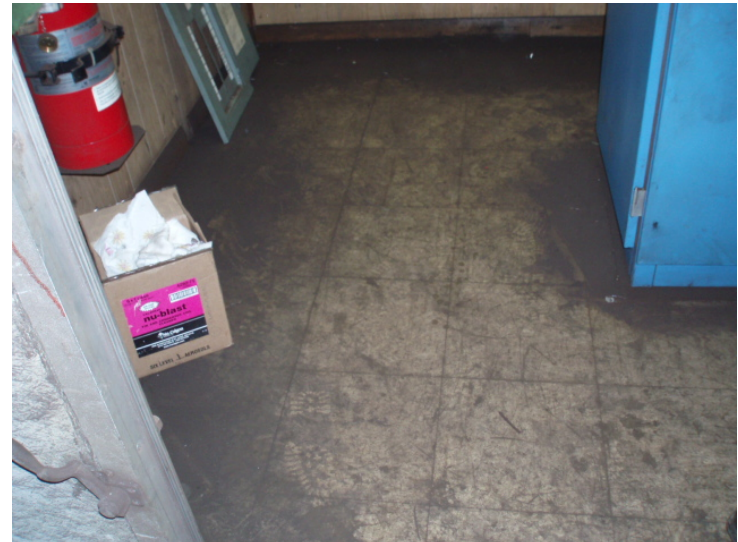
14. View of suspect asbestos-containing vinyl floor tiles located within a communications room within the Project Corridor.

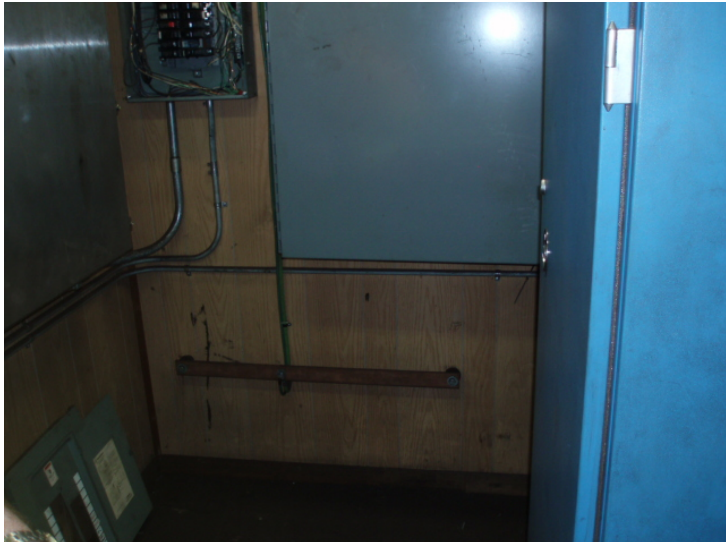
15. View of wood wall paneling and suspect asbestos-containing wall panel glue located within a communications room.

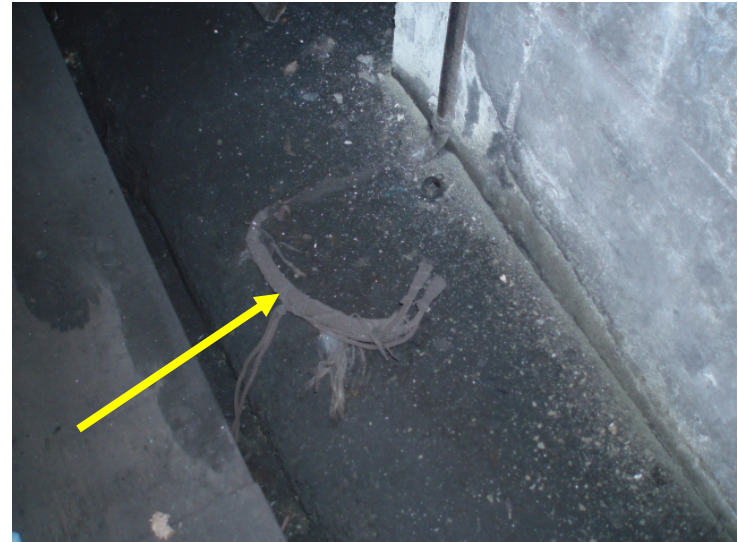
16. View of suspect asbestos-containing, woven wire insulation found in Bowdoin Yard Tunnel
